Release Note for AIC SAS 6G 2U24-2 Expander

Oct 31, 2018

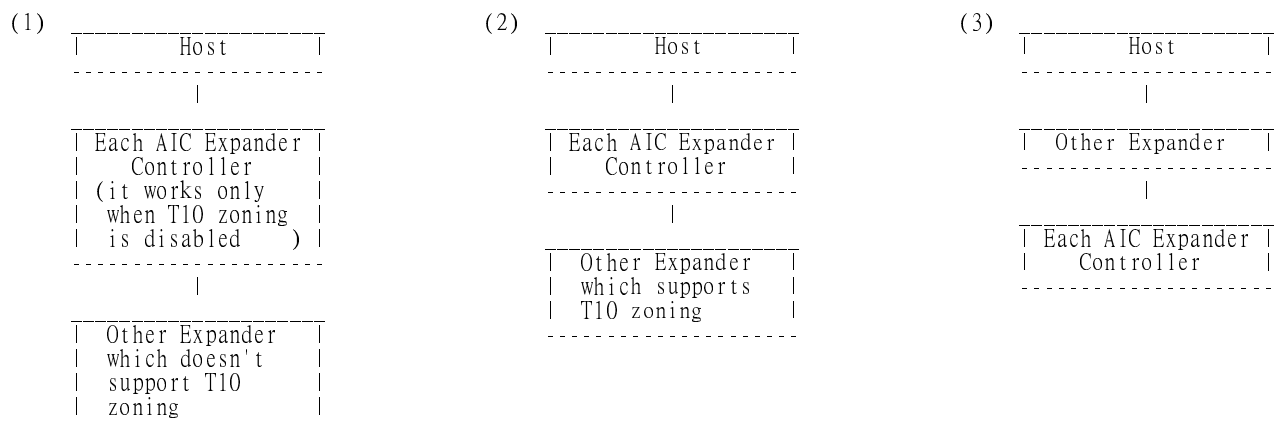
Supported Configuration

Most 3G Expanders don't support T10 zoning.
